Uttarakhand Flash Floods February 2021: Perils of Under-Preparedness or Disregard for the Environment or Both

Disaster hit Uttarakhand's Chamoli district on February 7, 2021, in the form of sudden flash floods after a portion of the Nanda Devi glacier was broke apart. The sudden floods were reported in the intricately linked tributaries of the Ganga River - Dhauli Ganga, Rishi Ganga, and Alaknanda rivers which triggered widespread panic and large-scale devastation and fatalities.

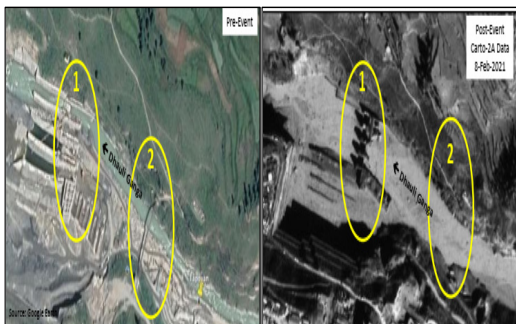
Rapid damage assessment was carried out of the affected areas using high-resolution satellite images. Indian Cartosat-2S images show damages at NTPC Power Project at Tapovan (Figure 3& 4). Table 2 shows the details of lives lost and damage/loss to infrastructure.

Figure 3: Satellite Images showing Damages to (1) Power Project, (2) Bridge

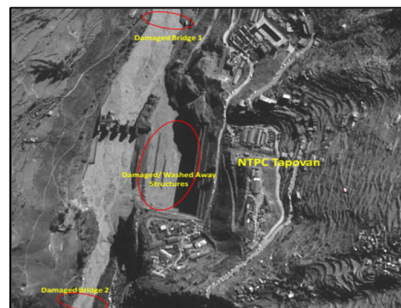
Figure 4: Satellite images showing Damages at NTPC, Tapovan
